## Observations, Fish and Habitat, Spring 2015

### Field Monitoring, Spring 2015

Weekly monitoring was done at 5 locations along northshore streams in the Clear Lake basin, checking for presence or absence of fish, especially Clear Lake hitch, *Lavinia exilicauda chi*, and of available habitat for them.

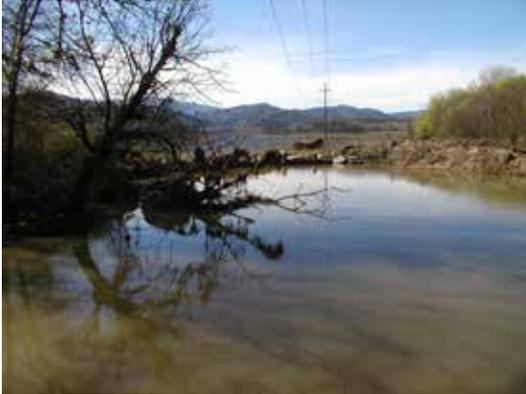
Pool, dam, and Tulelake beyond 2.19.2015

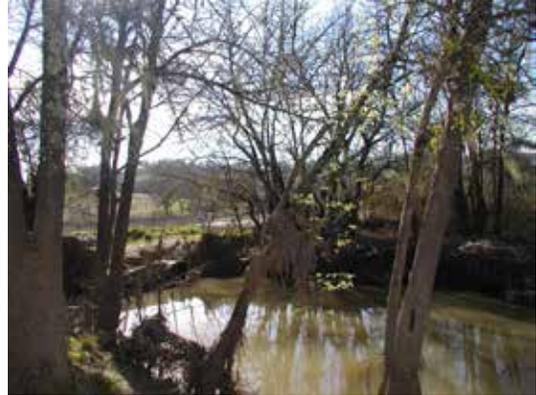
Scotts Creek enters the pooled area through this culvert. 2.19.2015

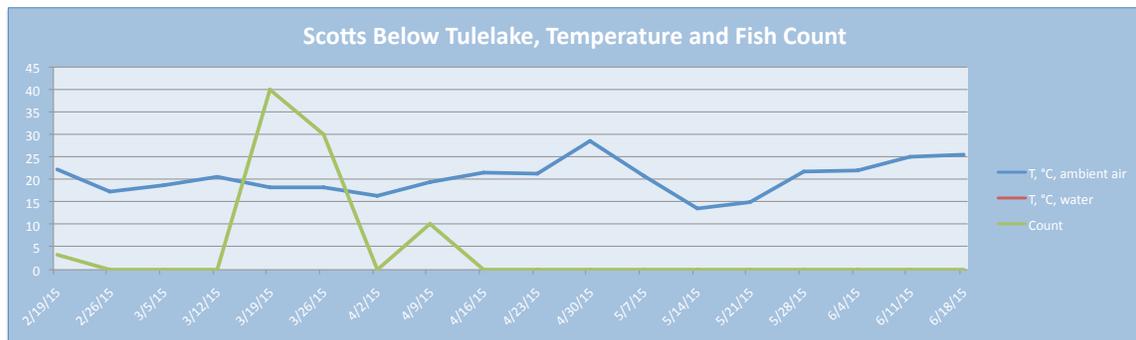
Water could not be accessed this year for temperatures, but ambient air was noted.

Estimated depth is likely quite inaccurate, however fluctuations in depth were visible on exposed banks especially by means of a landmark log or root structure. Flow was difficult to discern but generally when a slight flow was noted, a change in depth occurred.

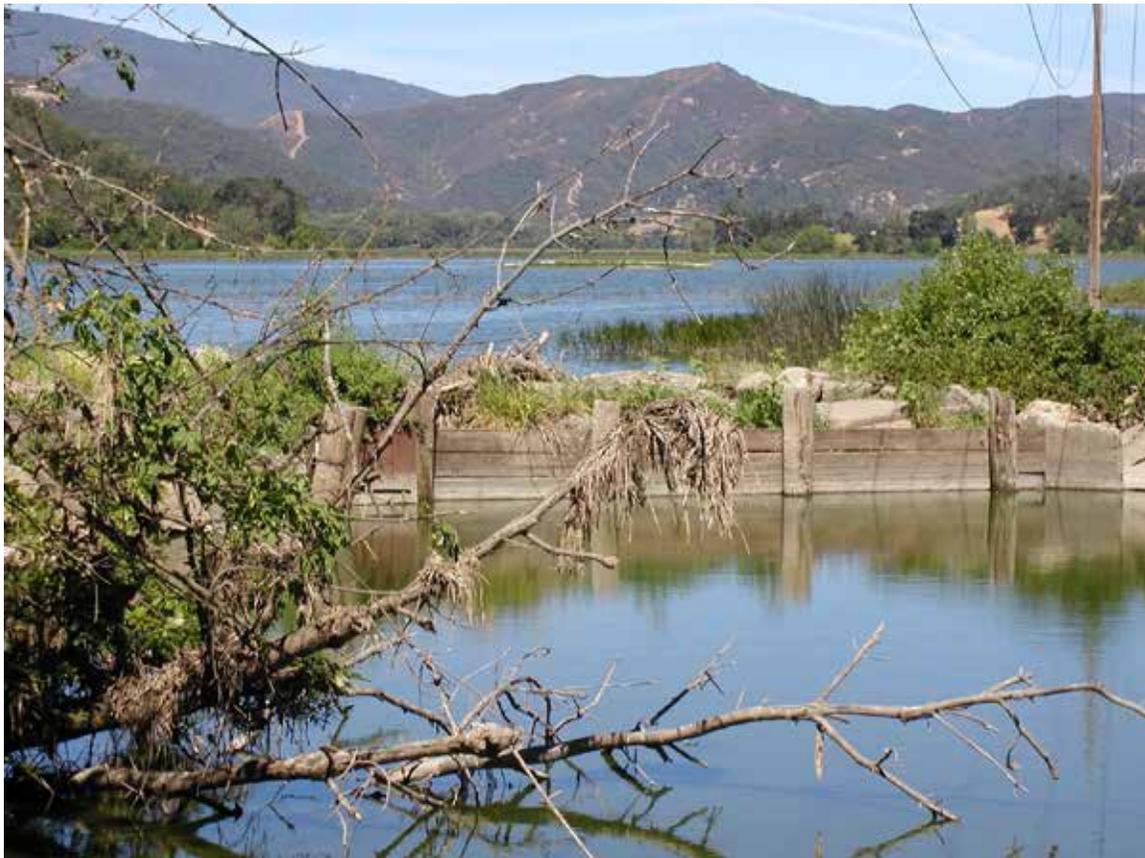
6.18.2015

Tulelake, dam, and pool

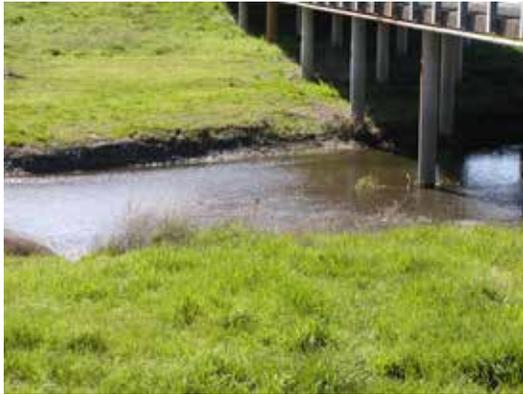
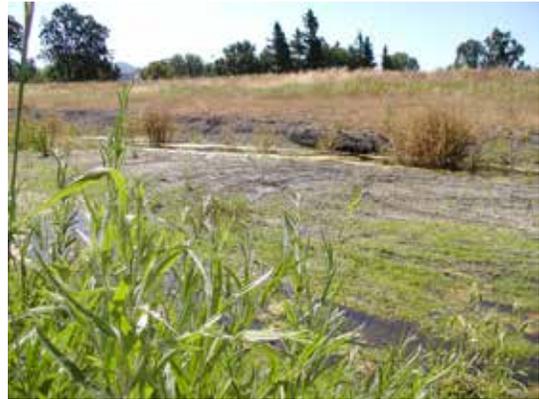
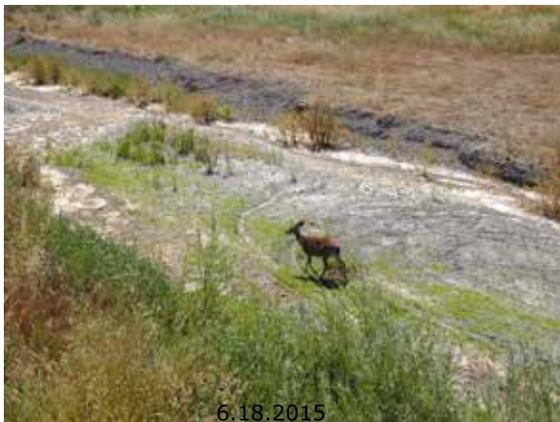
Water decreased steadily. The stream became braided and was dry on the final day. By this time, grasses and vetch on the levee's slope were thick, tall, and blooming or heading out.

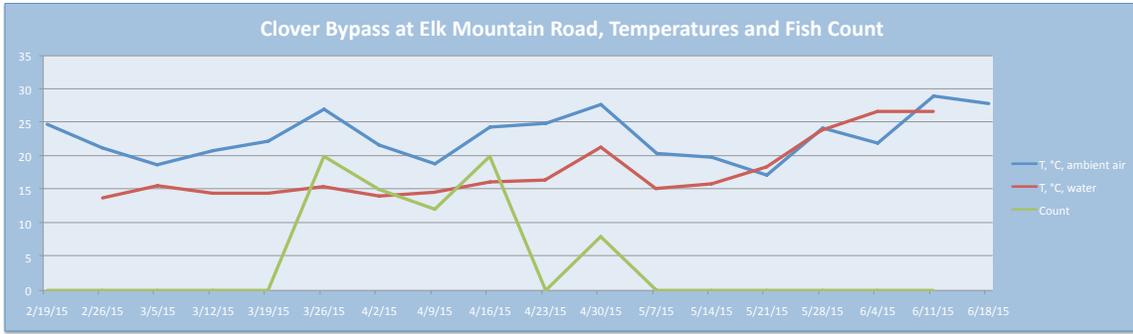
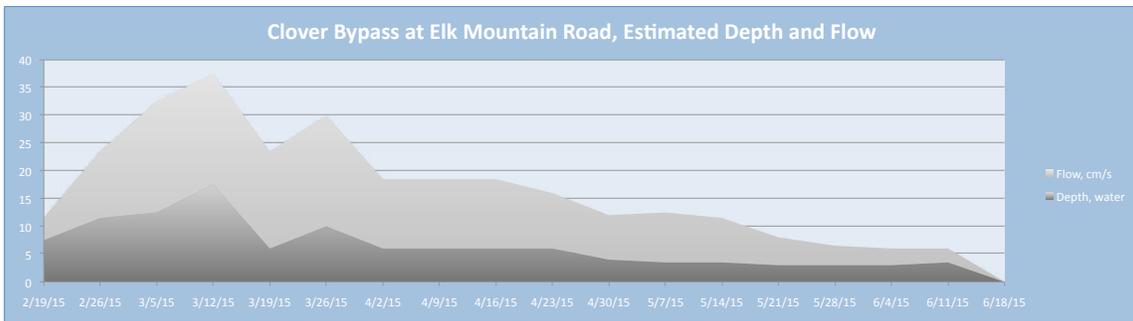
Juveniles were seen from 3.19.2015 to 5.7.2015.

Depth and flow varied widely across the channel. Averages from rough estimates are represented.

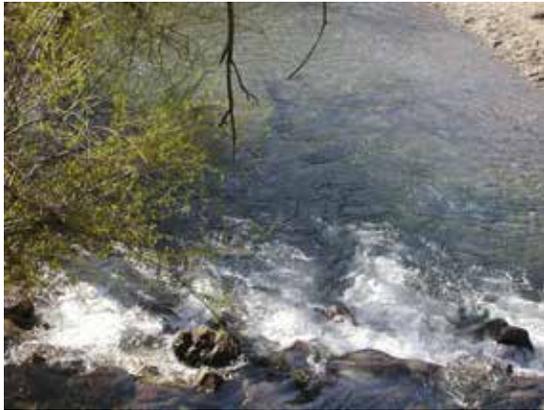
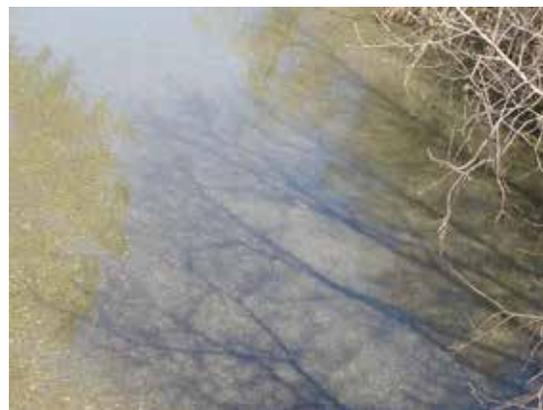
Downstream, and upstream, 2.20.2015

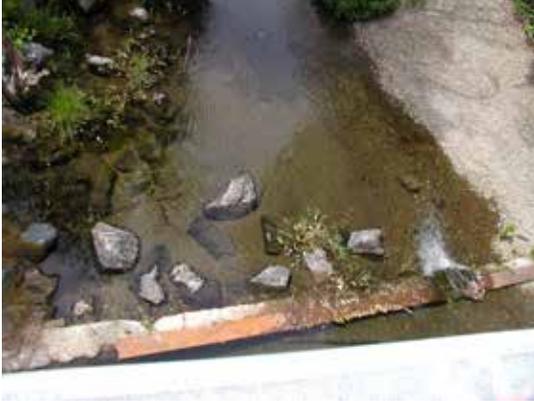
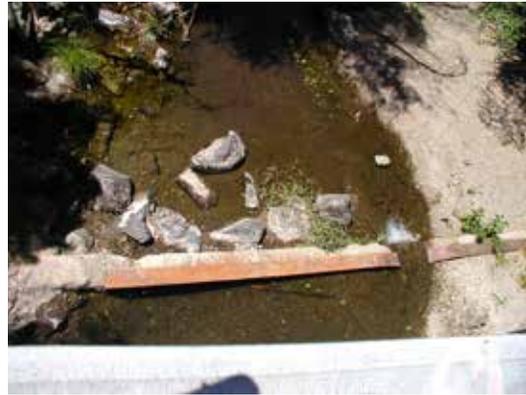
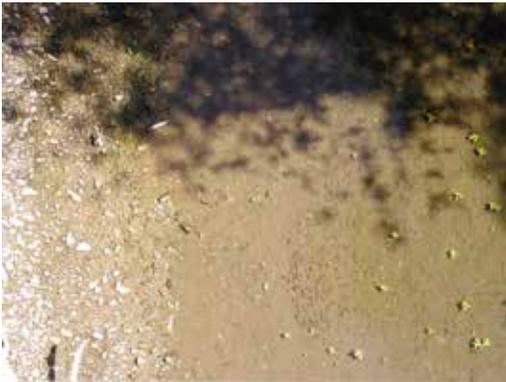
Access to a creekside location is now blocked. Notes and photos of downstream and upstream were taken from the bridge, but water temperatures could not be monitored. As temperatures warmed, algae grew over substrate and instream, and water and flow decreased, diminishing especially over the last few weeks of monitoring.

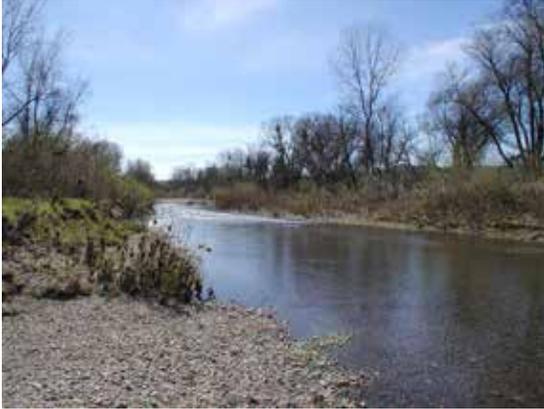
Downstream, 2.26.2015

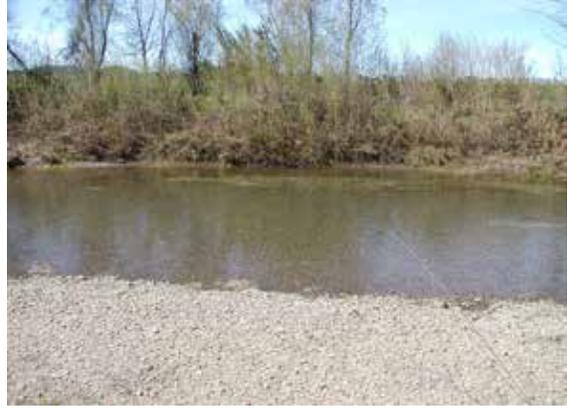
Across the channel, 2.26.2015

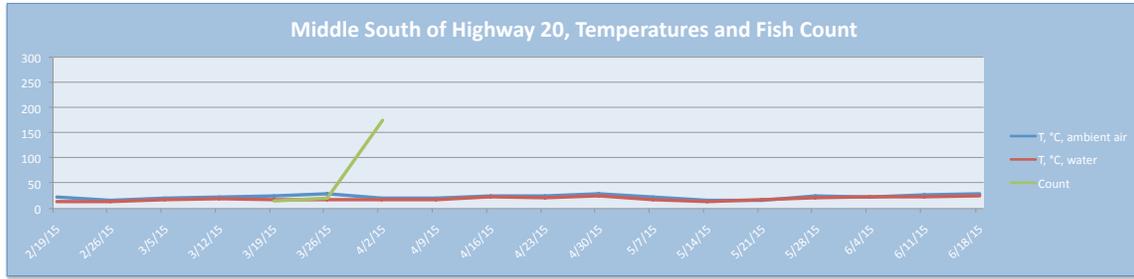
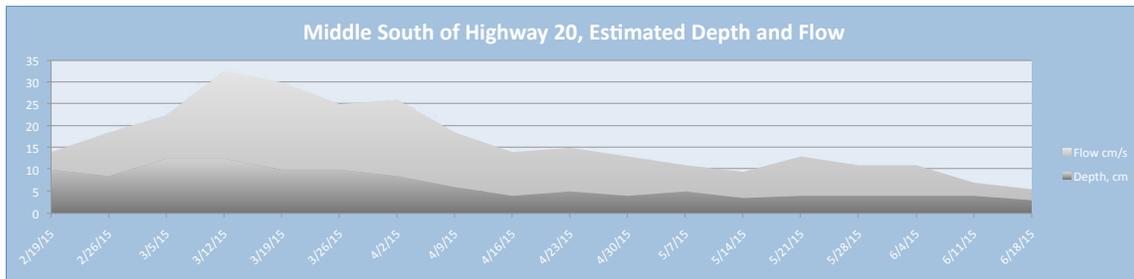
By the final day of observations, there was little water. Water still flowed here above ground. At places upstream it flowed under gravel, and fish passage was lost.

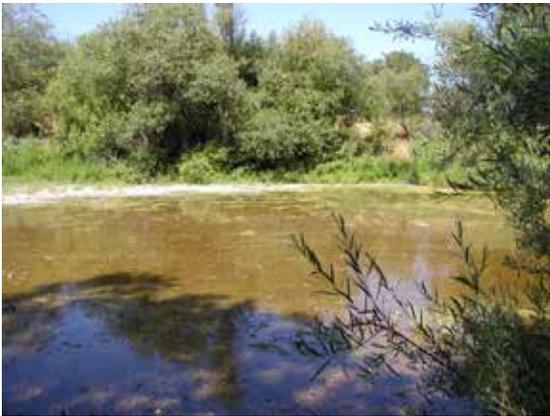
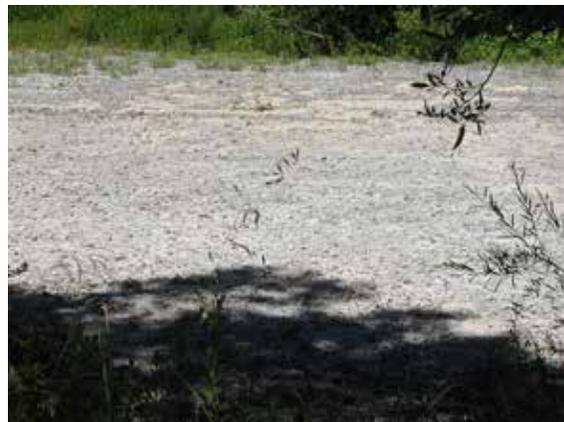
Water was clear. Various algae grew as water temperatures rose. This year few tadpoles, aquatic insects, and later, California toads were observed. Water gradually diminished, and on the last day this location was dry. Small pools and narrow, shallow channel flows were visible at places upstream and downstream.

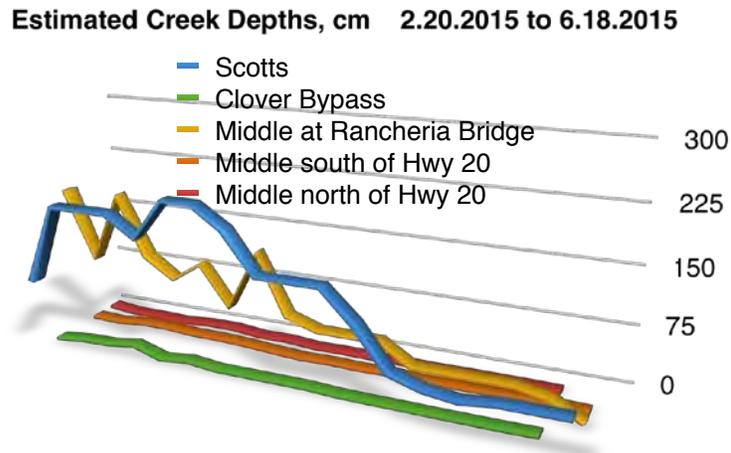
The following chart, again, represents only indications of potential fluctuations in creek depth and flow, because only week-by-week estimates, not measurements, were noted.
